Asbestos Survey

Survey to Identify Asbestos Containing Materials

06/48

Old Bank
33-39 Murraygate
Dundee

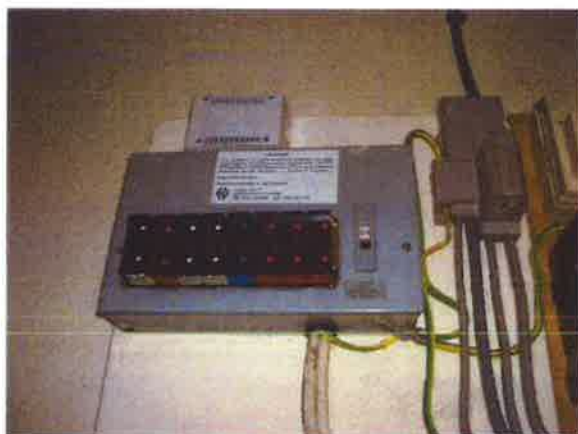
Item/Component: Fuses

Analysis Result: <div style="text-align: center; font-weight: bold; font-size: 1.2em;">Strongly Presumed</div>

MATERIAL ASSESSMENT								TOTAL
Product Type		Damage/Deter.		Surface Treatmt.		Asbestos Type		
0		0		0	✓	0		8
1		1		1		1		
2	✓	2		2		2		
3		3	✓	3		3	✓

RECOMMENDATIONS:	
No Action Required	
Action Required	✓
Re-inspection after 12 months	✓
Isolate	
Enclose	
Encapsulate	
Repair	
Remove

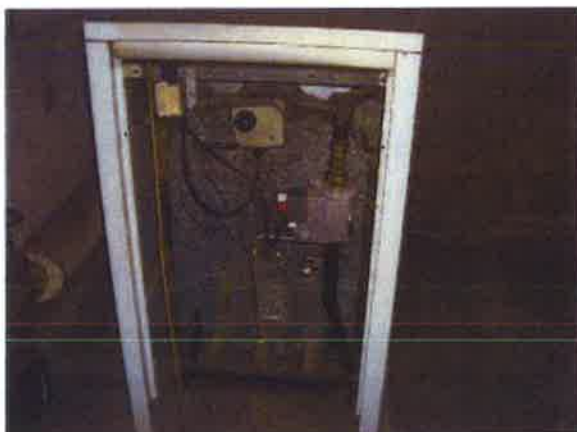
Room No/Area: Boiler Room Basement	Other Rooms/Areas Where Similar Material Presumed: N/A
Item/Component: Gas Boiler	
Sample Ref No: N/A

Analysis Result:	Strongly Presumed
------------------	--------------------------

MATERIAL ASSESSMENT							TOTAL
Product Type		Damage/Deter.		Surface Treatmt.		Asbestos Type	
0		0		0	✓	0	8
1		1		1		1	
2	✓	2		2		2	
3		3	✓	3		3

RECOMMENDATIONS:	
No Action Required	
Action Required	✓
Re-inspection after 12 months	✓
Isolate	
Enclose	
Encapsulate	
Repair	
Remove

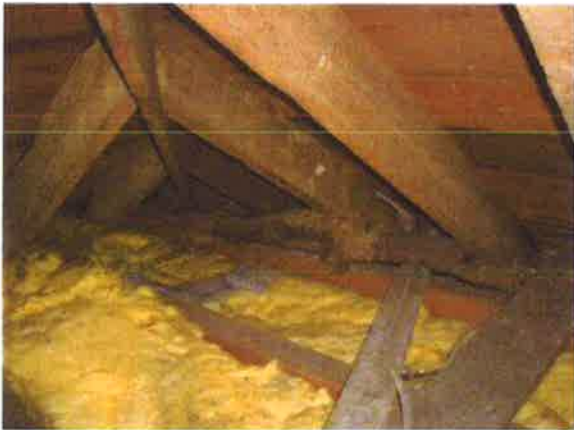
Room No/Area: Roof Void	Other Rooms/Areas Where Similar Material Presumed: N/A
Item/Component: Old Lagging	
Sample Ref No: 064801

Analysis Result: No Asbestos Detected

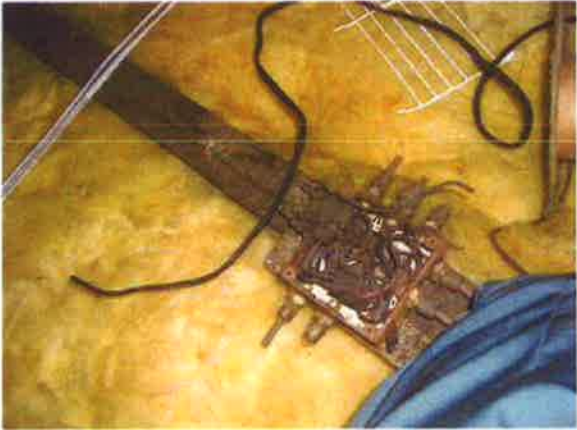
Room No/Area: Roof Void	Other Rooms/Areas Where Similar Material Presumed: N/A
Item/Component: Rubber Wire Covering	
Sample Ref No: 064802

Analysis Result: No Asbestos Detected

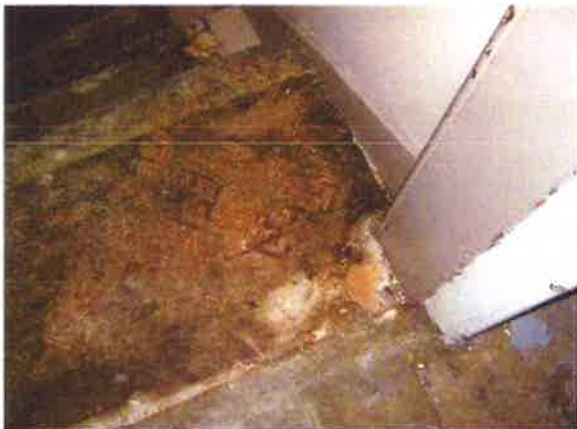
Room No/Area: Stairs from Top Floor	Other Rooms/Areas Where Similar Material Presumed: Throughout Stairs
Item/Component: Floor Lino	
Sample Ref No: 064804

Analysis Result: No Asbestos Detected

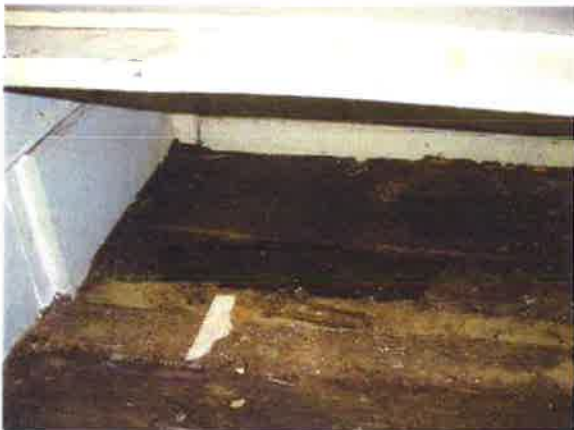
Room No/Area: Store 2, Top Floor	Other Rooms/Areas Where Similar Material Presumed: N/A
Item/Component: Tar on Floor	
Sample Ref No: 064805

Analysis Result: No Asbestos Detected

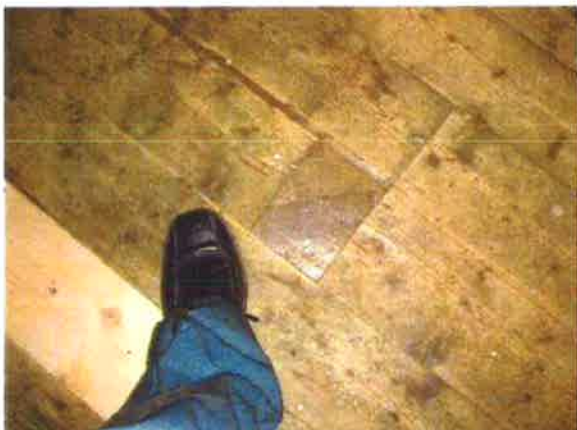
Room No/Area: Office 2 Top Floor	Other Rooms/Areas Where Similar Material Presumed: N/A
Item/Component: Backing on Floor	
Sample Ref No: 064808

Analysis Result: No Asbestos Detected

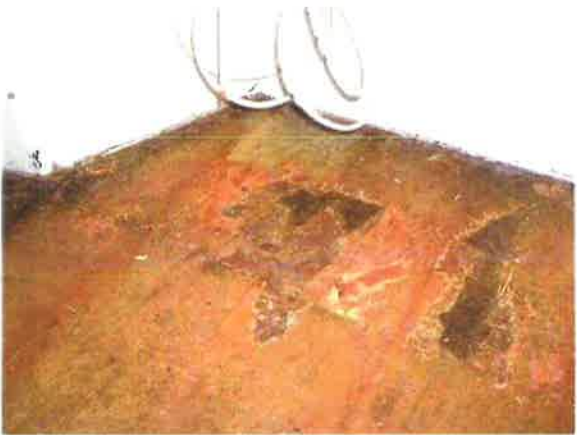
Room No/Area: Office 2 Top Floor	Other Rooms/Areas Where Similar Material Presumed: N/A
Item/Component: Floor Backing	
Sample Ref No: 064809

Analysis Result: No Asbestos Detected

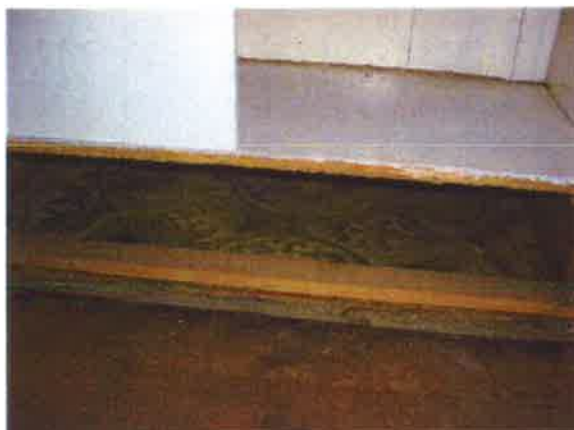
Item/Component: Carpet

No Asbestos Detected

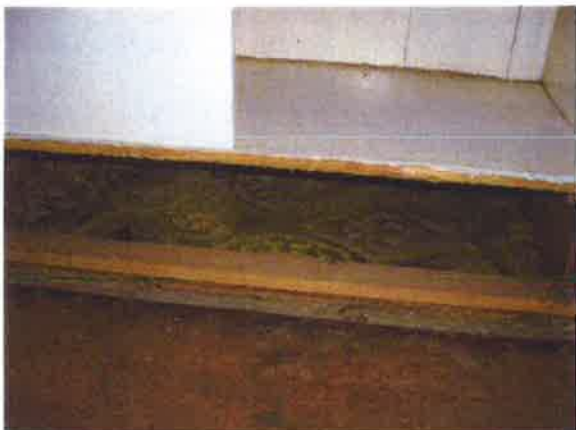
Room No/Area: Office 2 Top Floor, Under Recess Cupboard	Other Rooms/Areas Where Similar Material Presumed: N/A
Item/Component: Lino Under Carpet	
Sample Ref No: 0648011

Analysis Result: <div style="text-align: center; font-weight: bold;">No Asbestos Detected</div>

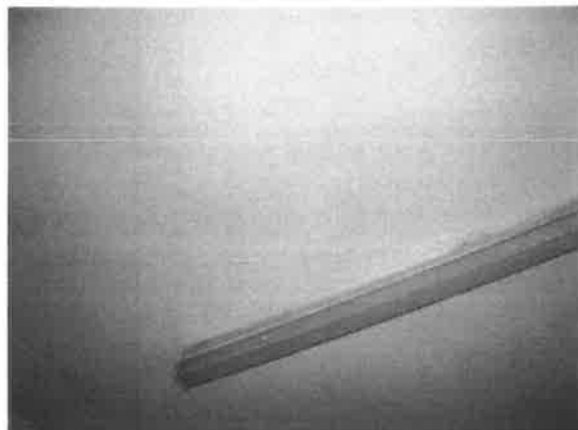
Item/Component: Ceiling Artex**Sample Ref No:**

No Asbestos Detected

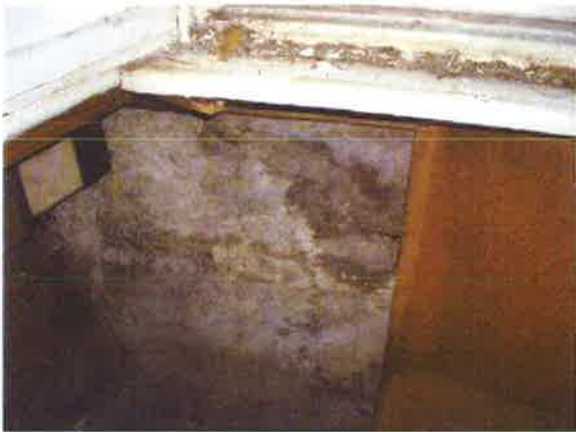
Room No/Area: Kitchen Top Floor	Other Rooms/Areas Where Similar Material Presumed: N/A
Item/Component: Wall Render	
Sample Ref No: 0648013

Analysis Result: No Asbestos Detected

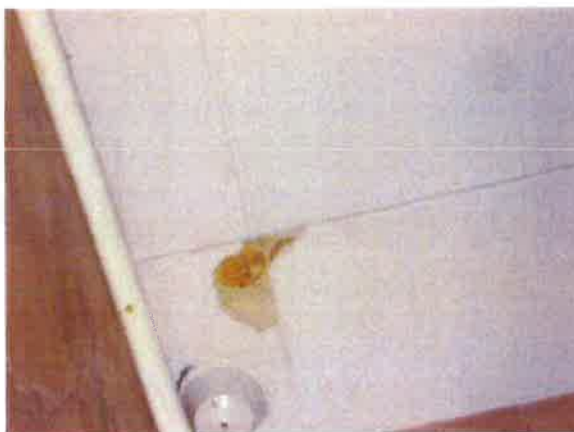
Item/Component: Adhesive on Ceiling Tile

No Asbestos Detected

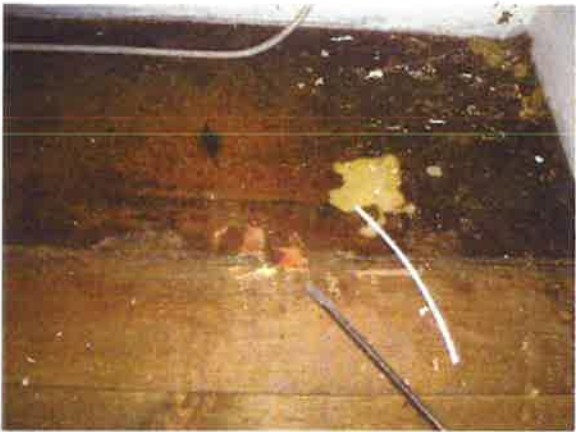
Room No/Area: Office 1 Top Floor	Other Rooms/Areas Where Similar Material Presumed: N/A
Item/Component: Floor Backing	
Sample Ref No: 0648014

Analysis Result: No Asbestos Detected

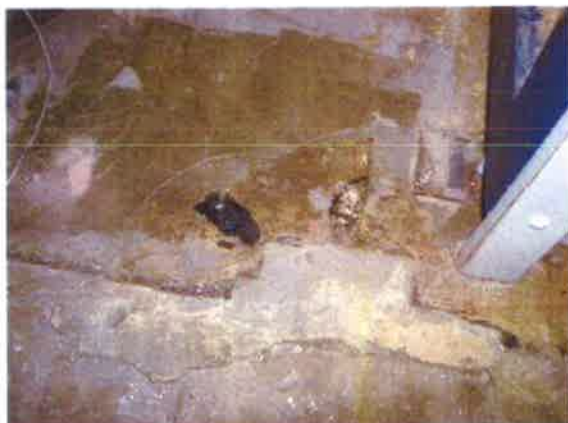
Item/Component: Floor Backing

No Asbestos Detected

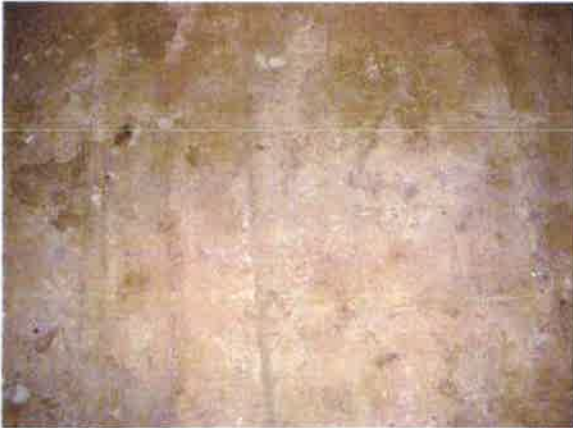
Room No/Area: Landing at Stairs Main Floor	Other Rooms/Areas Where Similar Material Presumed: N/A
Item/Component: Floor Backing	
Sample Ref No: 0648017

Analysis Result: No Asbestos Detected

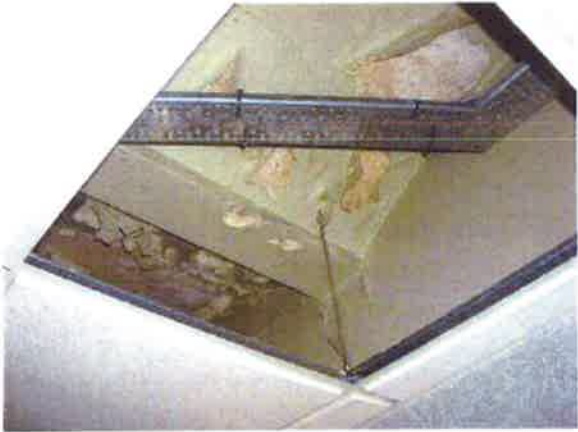
Room No/Area: Above Suspended Ceiling Store 1 Main Floor	Other Rooms/Areas Where Similar Material Presumed: N/A
Item/Component: Paint and Render	
Sample Ref No: 0648018

Analysis Result: No Asbestos Detected

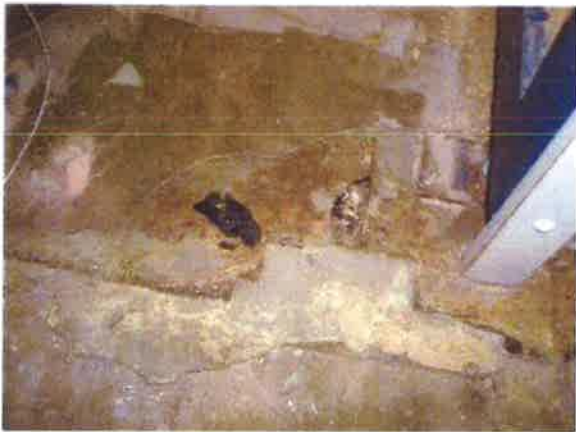
Room No/Area: Store 2 Main Floor	Other Rooms/Areas Where Similar Material Presumed: N/A
Item/Component: Floor Backing	
Sample Ref No: 0648019

Analysis Result: No Asbestos Detected

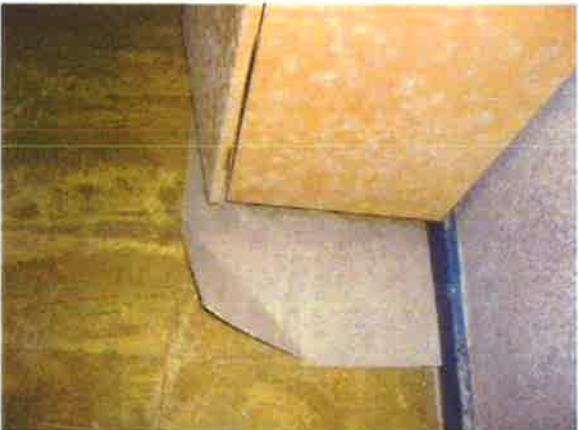
Room No/Area: Under Safe in Store 3 Main Floor	Other Rooms/Areas Where Similar Material Presumed: N/A
Item/Component: Lino	
Sample Ref No: 0648020

Analysis Result: <div style="text-align: center; font-weight: bold; font-size: 1.2em;">No Asbestos Detected</div>

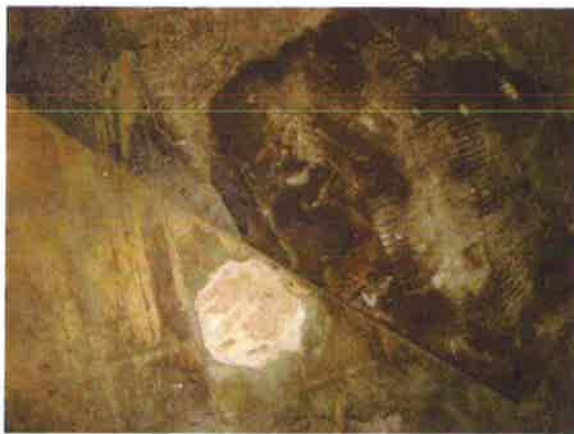
Item/Component: Floor Backing

No Asbestos Detected

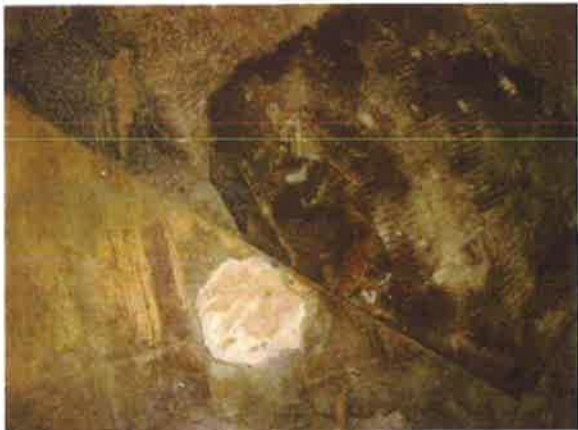
Room No/Area: Small Office Main Floor	Other Rooms/Areas Where Similar Material Presumed: N/A
Item/Component: Floor Backing (Black)	
Sample Ref No: 0648022

Analysis Result: No Asbestos Detected

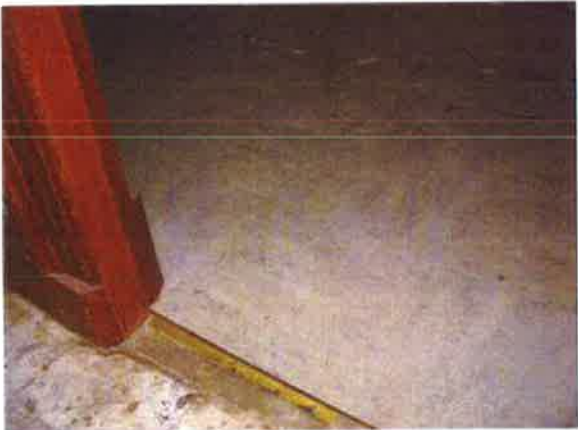
Room No/Area: Office 1 Main Floor	Other Rooms/Areas Where Similar Material Presumed: N/A
Item/Component: lino and Backing	
Sample Ref No: 0648024

Analysis Result: No Asbestos Detected

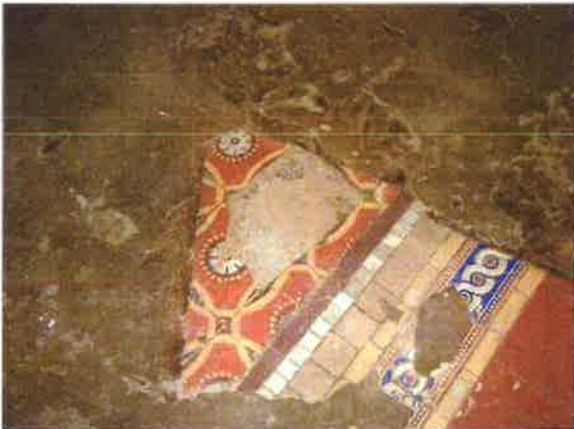
Room No/Area: Main Floor	Other Rooms/Areas Where Similar Material Presumed: N/A
Item/Component: Floor Debris	
Sample Ref No: 0648025

Analysis Result: No Asbestos Detected

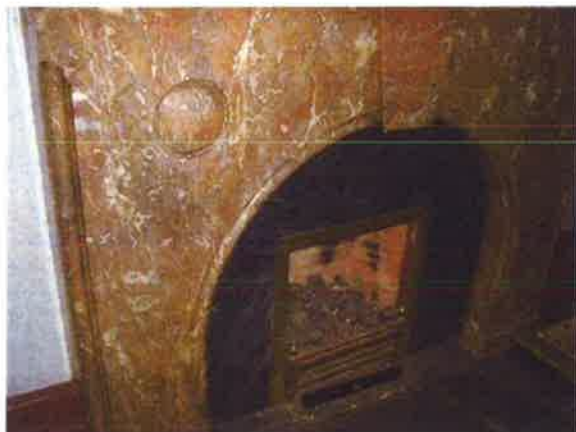
Item/Component: Fire Brick

No Asbestos Detected

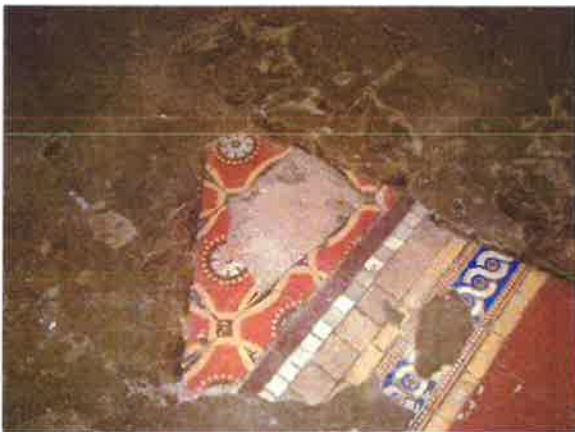
Room No/Area: Main Floor	Other Rooms/Areas Where Similar Material Presumed: N/A
Item/Component: Ceramic Floor Tiles	
Sample Ref No: 0648027

Analysis Result: No Asbestos Detected

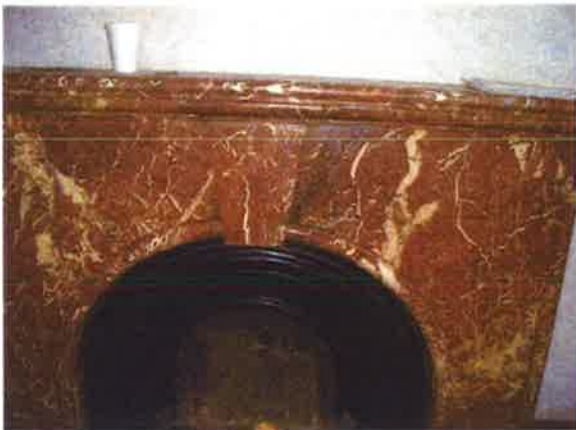
Room No/Area: Main Hall	Other Rooms/Areas Where Similar Material Presumed: N/A
Item/Component: Fire Coals	
Sample Ref No: 0648030

Analysis Result: No Asbestos Detected

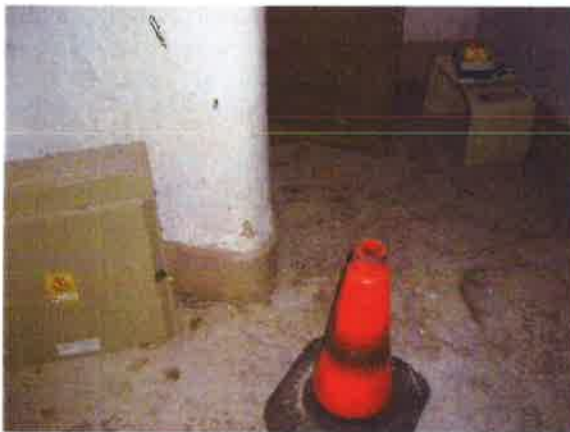
Item/Component: Floor Screed

No Asbestos Detected

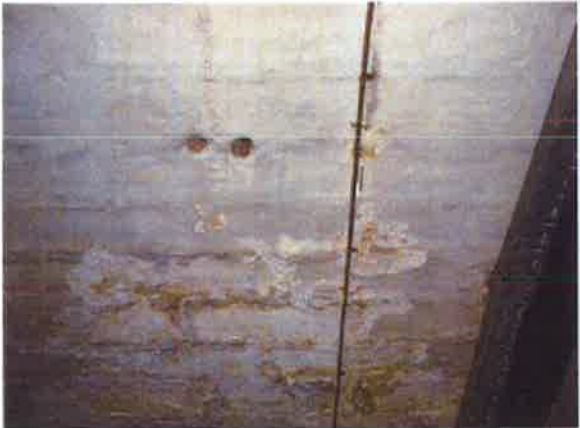
Room No/Area: Basement	Other Rooms/Areas Where Similar Material Presumed: Throughout Basement
Item/Component: Ceiling Covering	
Sample Ref No: 0648032

Analysis Result: <div style="text-align: center;">No Asbestos Detected</div>

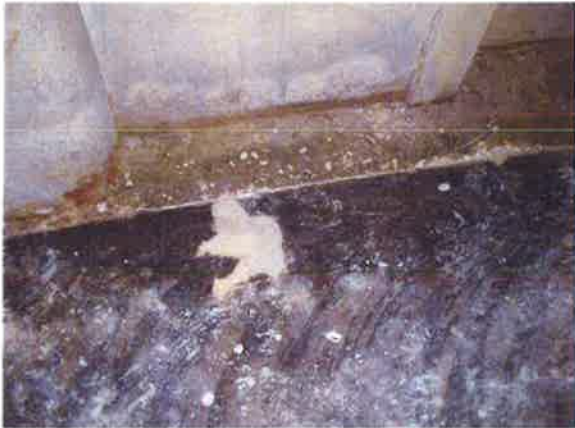
Room No/Area: Store 2 Basement	Other Rooms/Areas Where Similar Material Presumed: N/A
Item/Component: Floor Covering (Black)	
Sample Ref No: 0648033

Analysis Result: No Asbestos Detected

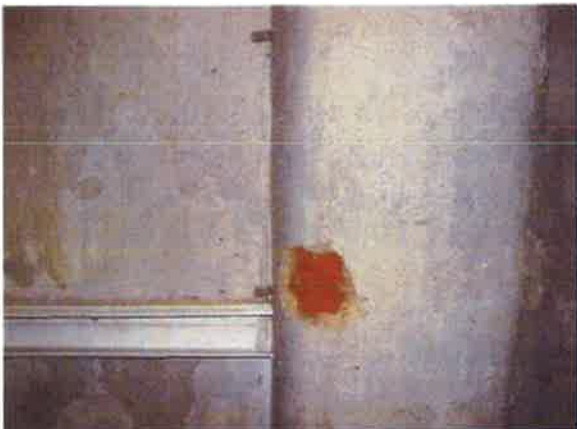
Room No/Area: Basement Wall Render	Other Rooms/Areas Where Similar Material Presumed: N/A
Item/Component: Wall Render	
Sample Ref No: 0648034

Analysis Result: No Asbestos Detected

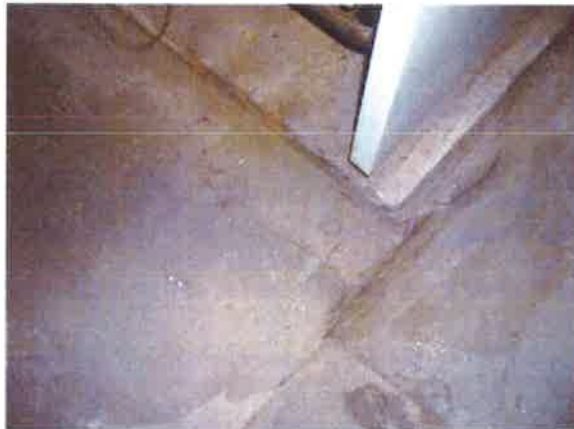
Item/Component: Floor Screed

No Asbestos Detected
