Refurbishment Asbestos Survey

**1/3 Murraygate,
Dundee,
DD1 2EE**

Report Ref: RAAD39405/31822

21 January 2016

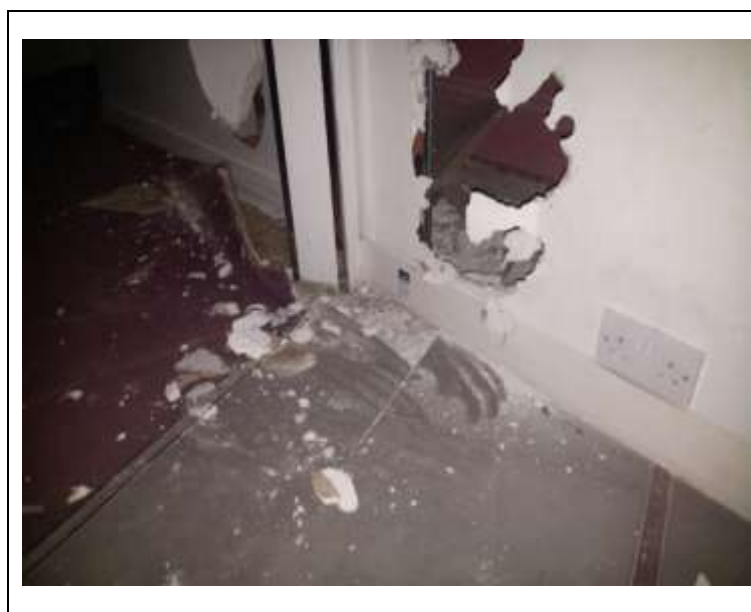
Site:	1/3 Murraygate	Date of Survey:	21st January 2016
Building:	-	Survey Conducted By:	Cameron Duncan (Lead)
Floor:	Ground Floor		
Room Ref:	0/001 Shop	Sample No:	183507
Form:	Cement Products	Lab Analysis Result:	Not Detected
Extent:	Throughout		
Location:	Floor screed

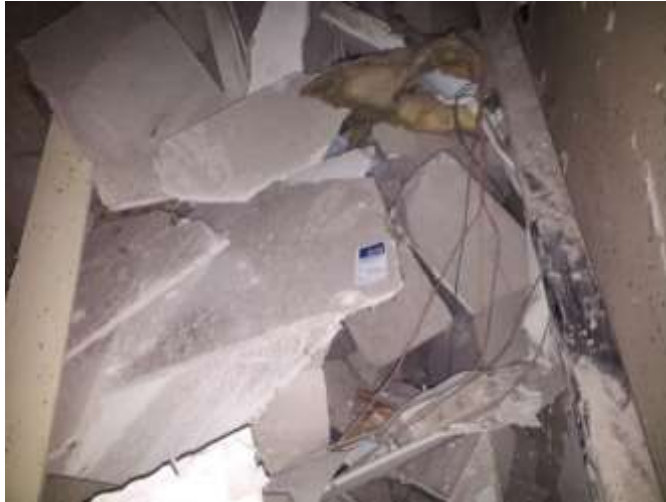
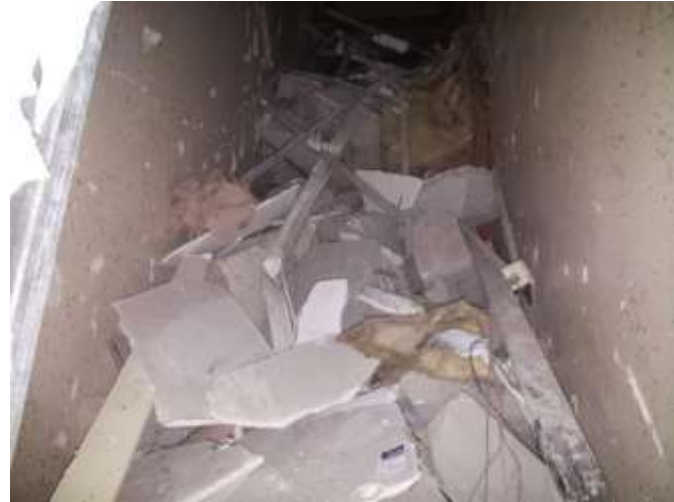
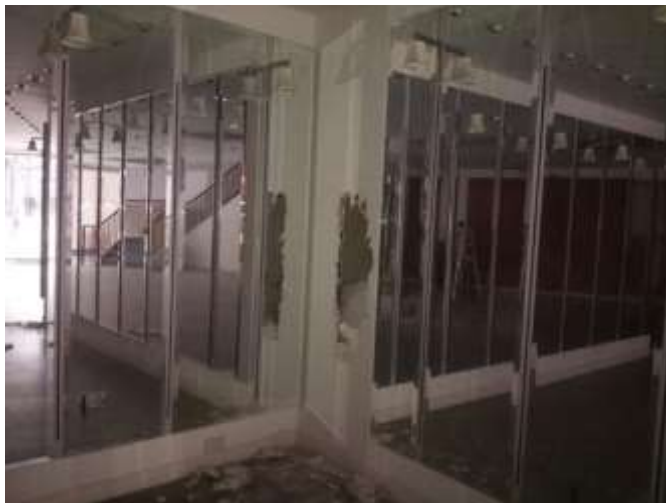
No suspect materials were discovered during the course of this survey, however a blocked up stairwell was discovered behind a plasterboard wall in the ground floor main shop area. Although only non-asbestos materials were identified within this area, it was not safe to access underneath the large amount of rubble/debris. If, during any refurbishment works within this stairwell, any suspicious materials are discovered then work should immediately be suspended until further investigations are undertaken.

Site:	1/3 Murraygate	Date of Survey:	21st January 2016
Building:	-	Survey Conducted By:	Cameron Duncan (Lead)
Floor:	Ground Floor		
Room Ref:	0/001 Shop		
Form:	Debris/Residue	Sample No:	183508
Extent:	Throughout	Lab Analysis Result:	Not Detected
Location:	Insulating board debris to blocked off stairwell behind plasterboard

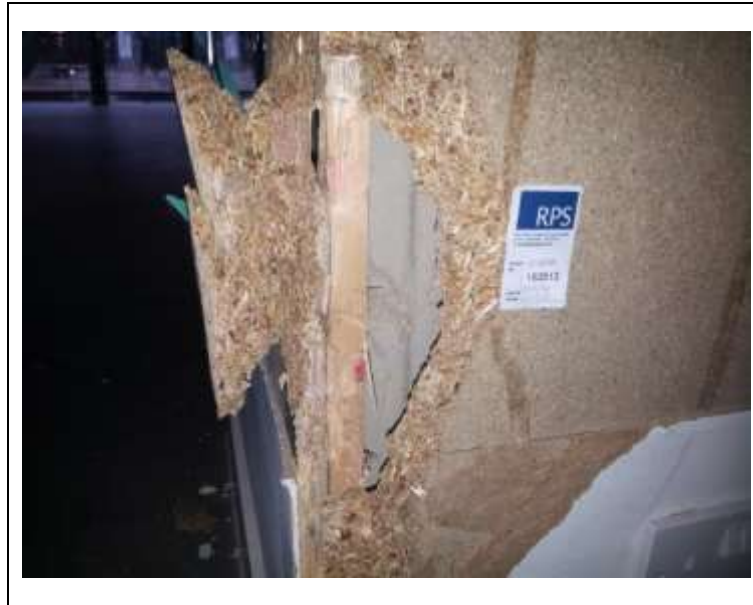
Site:	1/3 Murraygate	Date of Survey:	21st January 2016
Building:	-	Survey Conducted By:	Cameron Duncan (Lead)
Floor:	Ground Floor		
Room Ref:	0/001 Shop		
Form:	Insulating Board Products	Sample No:	183513
Extent:	16 sqm	Lab Analysis Result:	Not Detected
Location:	Column cladding under timber

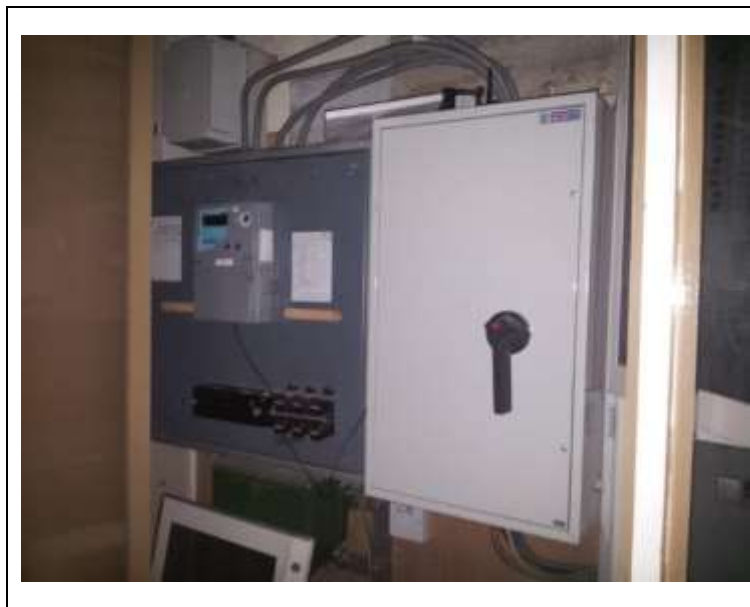
It was not possible to access within the live electrical switchgear in the ground floor stock room. If the switchgear is to be accessed or replaced, they should first be assessed by suitably trained personnel once the electrical supply has been isolated.

Site:	1/3 Murraygate	Date of Survey:	21st January 2016
Building:	-	Survey Conducted By:	Cameron Duncan (Lead)
Floor:	Ground Floor		
Room Ref:	0/003 Stock Room		
Form:	-	Sample No:	-
Extent:	-	Lab Analysis Result:	Presumed
Location:	Within live electrical switchgear

Room Ref	Asbestos	Sample Ref	Form	Location	Extent	Risk Assessment	Action By
0/003 Stock Room	Limitations	-	-	Within live electrical switchgear	-	TBC	Before Works
		Recommendations: Non-accessed area. This area should be regarded as containing asbestos until assessed by a competent person.					
		Comments: No access within live electrical switchgear. Plasterboard ceiling tiles, plasterboard walls, plaster over brick walls, modern vinyl over timber flooring.

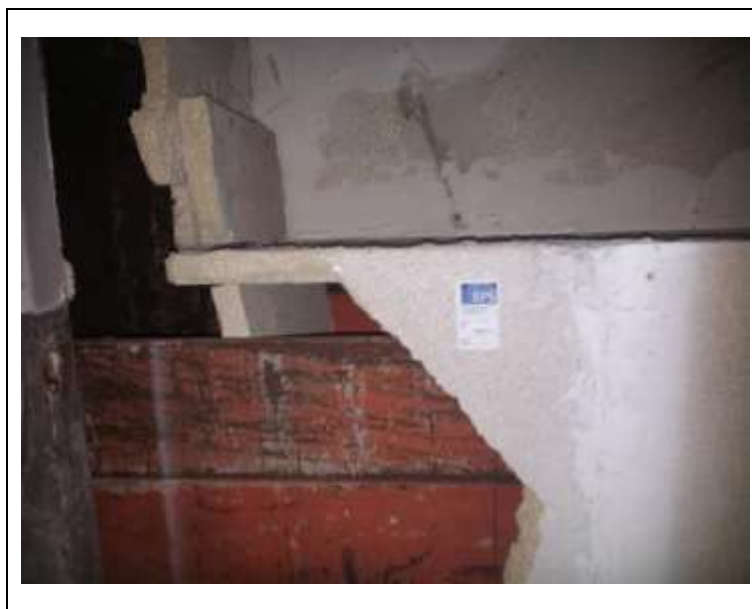
Site:	1/3 Murraygate	Date of Survey:	21st January 2016
Building:	-	Survey Conducted By:	Cameron Duncan (Lead)
Floor:	Ground Floor		
Room Ref:	0/004 Ceiling Void		
Form:	Insulating Board Products	Sample No:	183511
Extent:	Throughout	Lab Analysis Result:	Not Detected
Location:	Cladding to metal beams

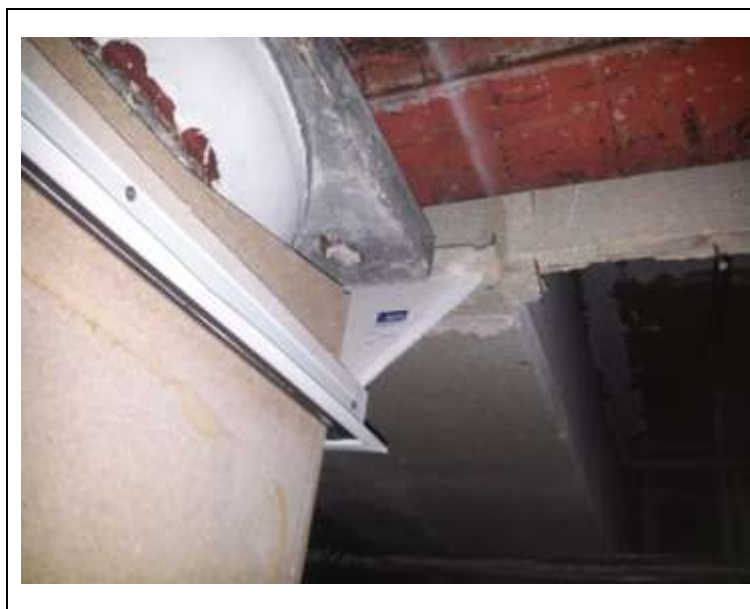
Site:	1/3 Murraygate	Date of Survey:	21st January 2016
Building:	-	Survey Conducted By:	Cameron Duncan (Lead)
Floor:	Ground Floor		
Room Ref:	0/004 Ceiling Void		
Form:	Insulating Board Products	Sample No:	183512
Extent:	4 sqm	Lab Analysis Result:	Not Detected
Location:	Insulating board panels to column top

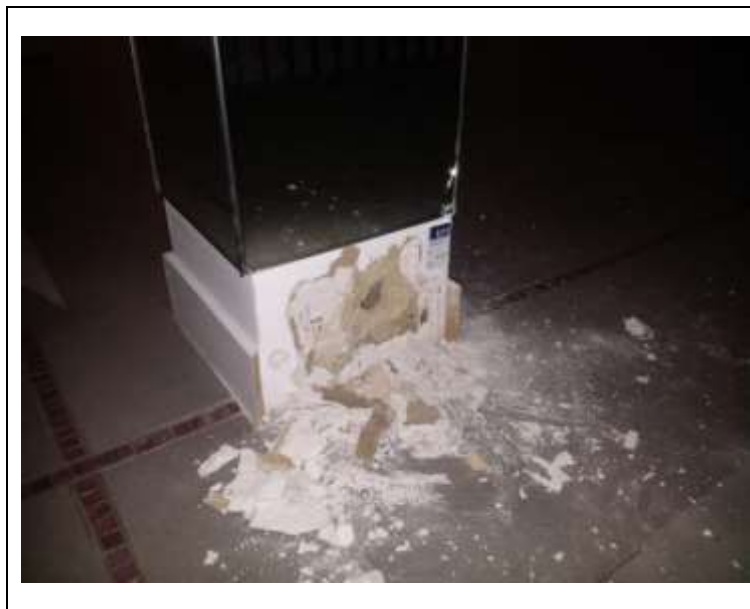
Site:	1/3 Murraygate	Date of Survey:	21st January 2016
Building:	-	Survey Conducted By:	Cameron Duncan (Lead)
Floor:	First Floor		
Room Ref:	1/001 Shop		
Form:	Insulating Board Products	Sample No:	183509
Extent:	32 sqm	Lab Analysis Result:	Not Detected
Location:	Insulating board cladding to columns

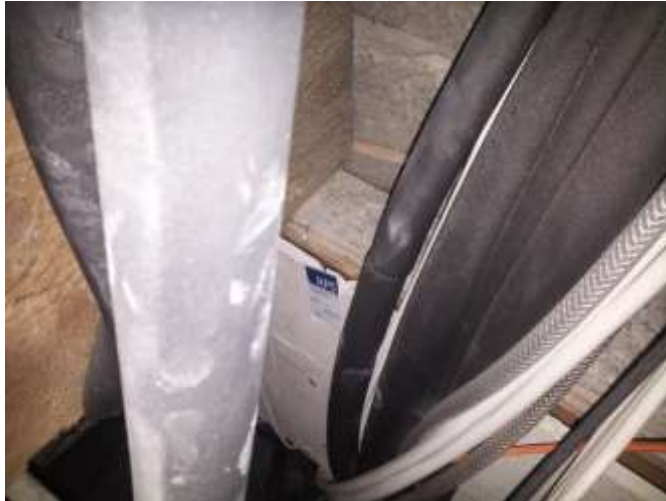
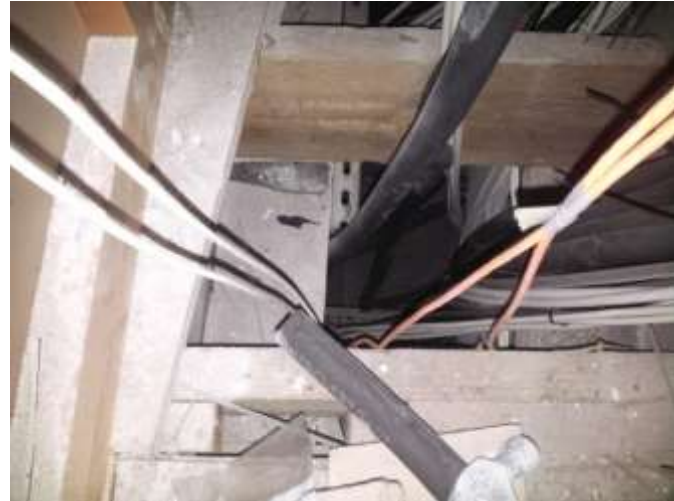
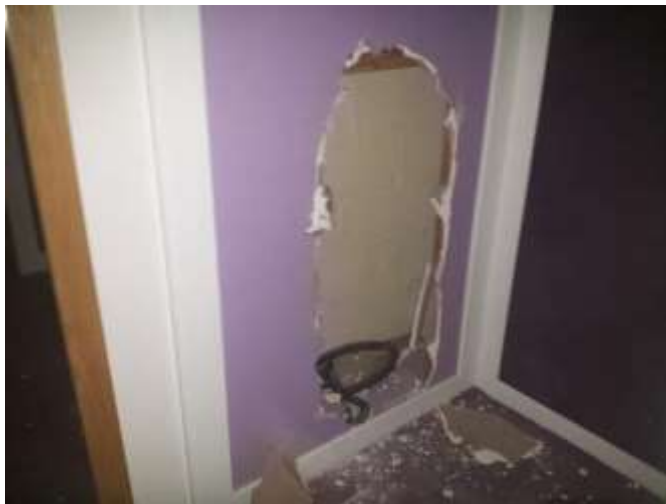
Site:	1/3 Murraygate	Date of Survey:	21st January 2016
Building:	-	Survey Conducted By:	Cameron Duncan (Lead)
Floor:	First Floor		
Room Ref:	1/002 Changing Rooms		
Form:	Insulating Board Products	Sample No:	183510
Extent:	Throughout	Lab Analysis Result:	Not Detected
Location:	Insulating board panels to floor void

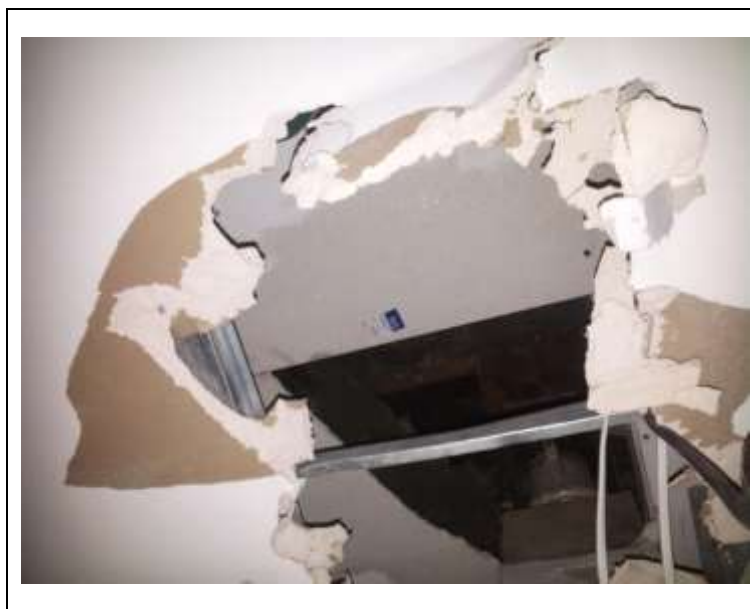
Site:	1/3 Murraygate	Date of Survey:	21st January 2016
Building:	-	Survey Conducted By:	Cameron Duncan (Lead)
Floor:	First Floor		
Room Ref:	1/009 Ceiling Void		
Form:	Insulating Board Products	Sample No:	183514
Extent:	Throughout	Lab Analysis Result:	Not Detected
Location:	Insulating board panels to ceiling above plasterboard ceiling
