Asbestos Survey

Survey to Identify Asbestos Containing Materials

06/48

Old Bank
33-39 Murraygate
Dundee

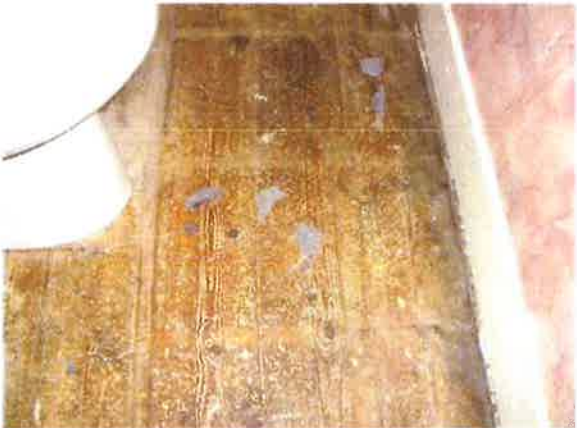
Site Address: Old Bank 33-39 Murraygate Dundee	Date: 20/12/06	Sheet No: 07
	Ref: 06/48	Surveyor: Ross Duguid

Room No/Area: Shower Room Top Floor	Other Rooms/Areas Where Similar Material Presumed: N/A
Item/Component: Floor Covering	
Sample Ref No: 064807

Analysis Result:

Non-Asbestos Containing Materials Register

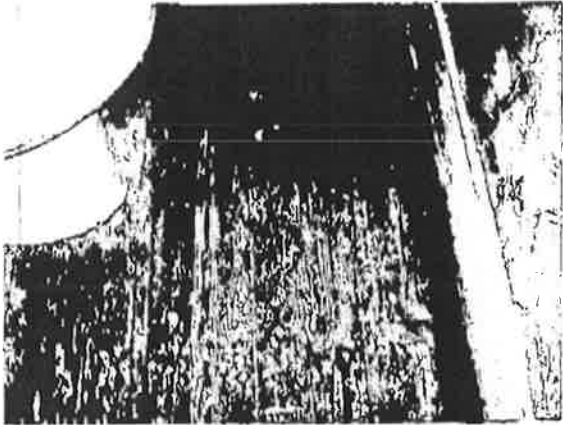
Site Address: Old Bank 33-39 Murraygate Dundee	Date: 20/12/08	Sheet No: 07
	Ref: 08/48	Surveyor: Ross Duguid

Room No/Area: Shower Room Top Floor	Other Rooms/Areas Where Similar Material Presumed: N/A
Item/Component: Floor Covering	
Sample Ref No: 064807

Analysis Result:

Non-Asbestos Containing Materials Register
