Refurbishment Asbestos Survey

**1/3 Murraygate,
Dundee,
DD1 2EE**

Report Ref: RAAD39405/31822

21 January 2016

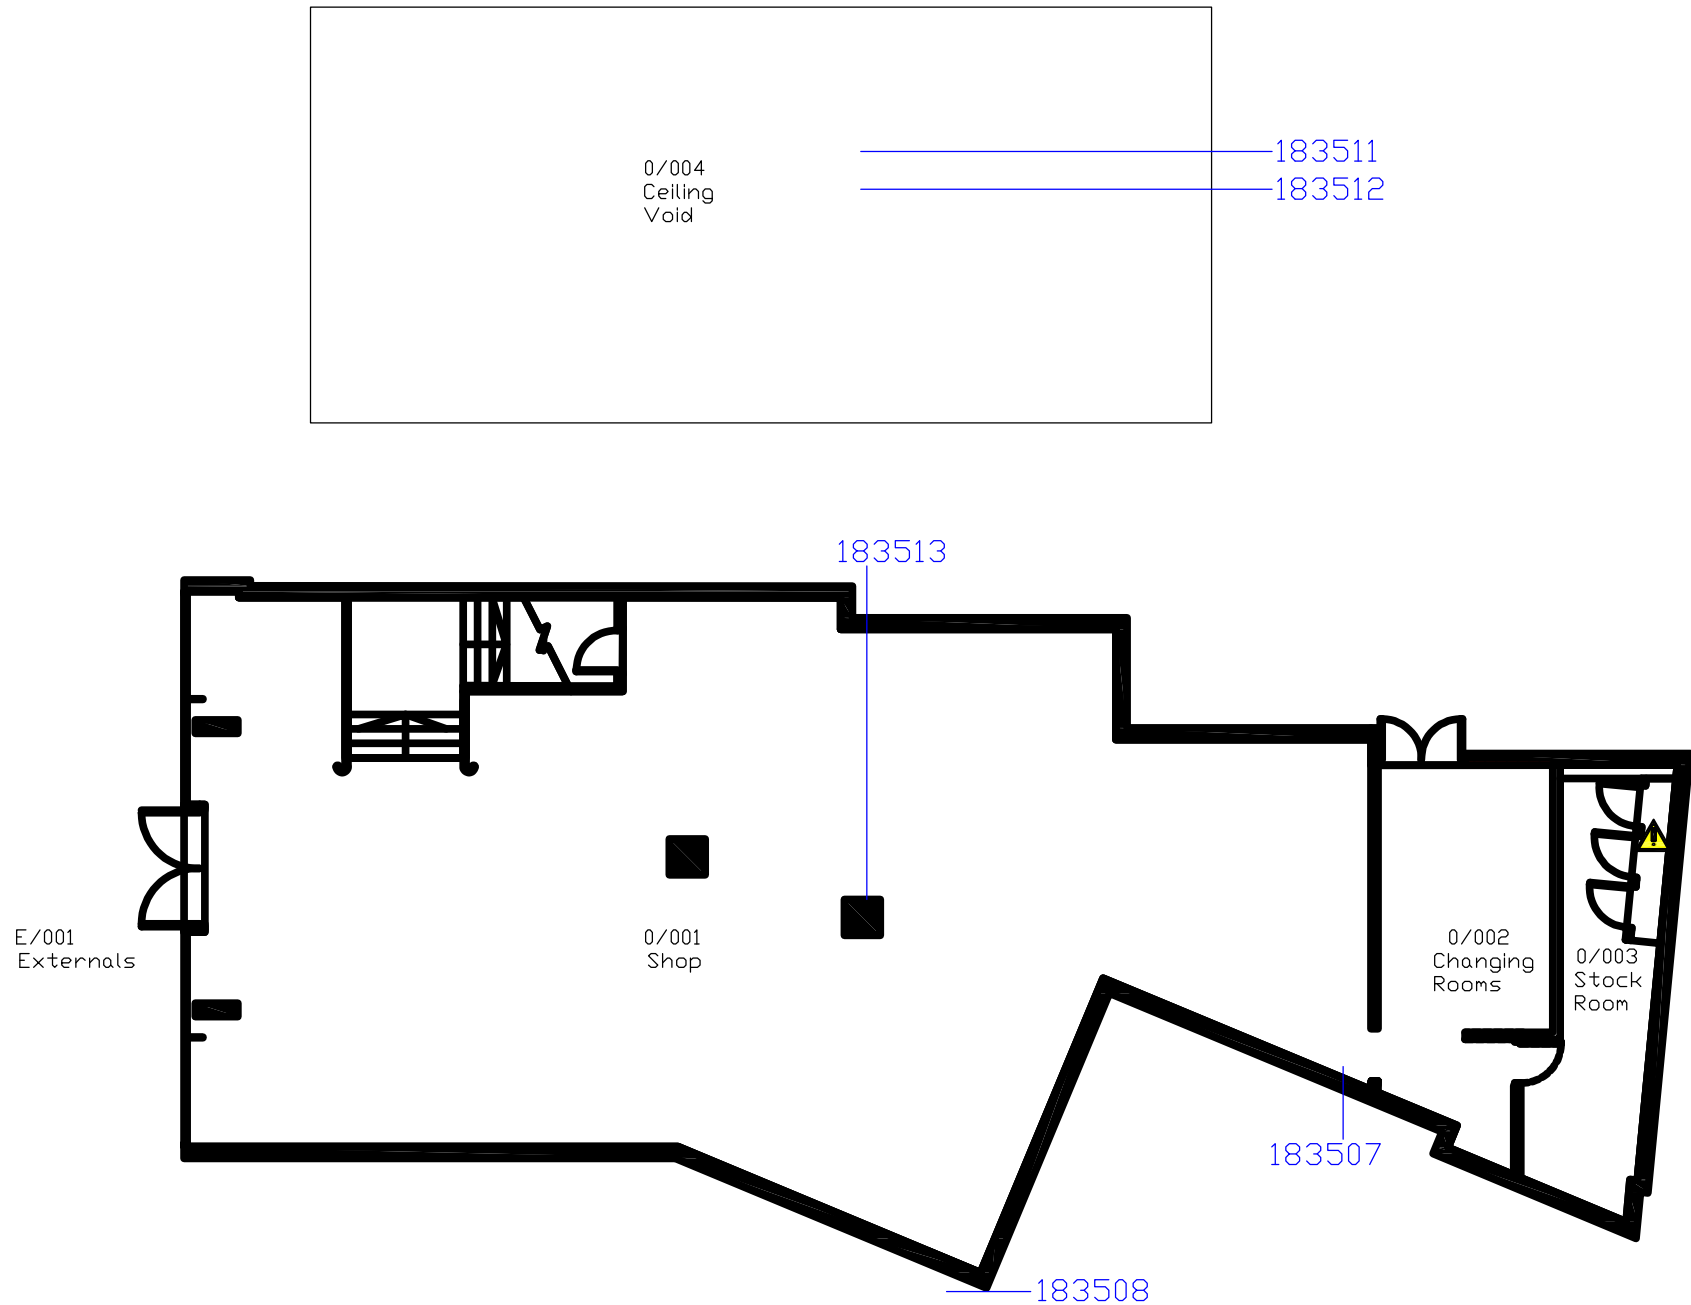
CLIENT: Aviva Life & Pensions UK Ltd
SITE: 1/3 Murraygate, Dundee
LOCATION: Ground Floor
SURVEY DATE: 21st & 27th January 2016
RPS DOC NUMBER: RAAD39405/31822
DRAWING REV: 0001
RPS SURVEYORS: CD, DL
DRAWN BY / DATE: CD 4th February 2016
CHECKED BY: SP

It was not possible to access within the live electrical switchgear in the ground floor stock room. If the switchgear is to be accessed or replaced, they should first be assessed by suitably trained personnel once the electrical supply has been isolated.
